Home Inspection Report

1234 School House Road
Yourtown, US 12345

Prepared for: Bob Smith

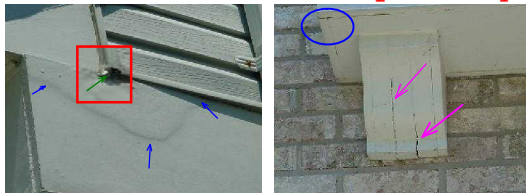
1. The wood window boxes have water damage and will require repair/replacement. The wood has started to separate at the supports and at the corners of the window boxes.

2. The trim board at the southwest corner of the porch has water damage due to water penetration and will require repair/replacement of the wood. The trim board extends out creating a ledge allowing water to collect on the top edge of the board and cause the wood to rot.

Recommend estimate/repairs by a qualified contractor.

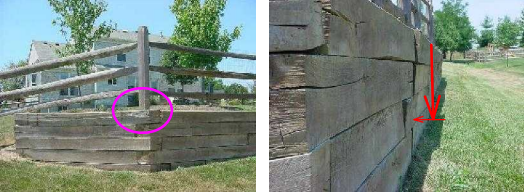
1. **Retaining Walls:** Railroad ties The wall is showing signs of movement, but appears stable at this time. Recommend an estimate by a qualified contractor to evaluate, estimate, and recommend repairs that may be required to maintain the retaining wall.
