Home Inspection Report

1234 School House Road
Yourtown, US 12345

Prepared for: Bob Smith

Prepared by: Your Company Name Here
9600 Colerain Ave
Suite 110
Cincinnati, OH 45215

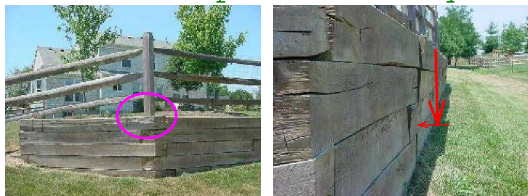
Retaining Walls: Railroad ties The wall is showing signs of movement, but appears stable at this time. Recommend an estimate by a qualified contractor to evaluate, estimate, and recommend repairs that may be required to maintain the retaining wall.

Grading: moderate The grade and landscaping materials are too high and extend above the window well at the Northeast rear of home. Recommend that the grade be reduced or the window well metal soil retainer be replaced with a taller soil retainer to keep the mulch and soil from washing into the window well.

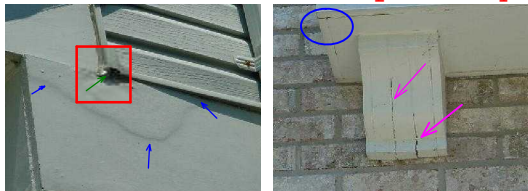
1. The wood window boxes have water damage and will require repair/replacement. The wood has started to separate at the supports and at the corners of the window boxes.

2. The trim board at the southwest corner of the porch has water damage due to water penetration and will require repair/replacement of the wood. The trim board extends out

creating a ledge allowing water to collect on the top edge of the board and cause the wood to rot.

Recommend estimate/repairs by a qualified contractor.

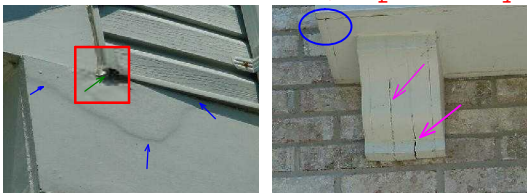
1. The wood window boxes have water damage and will require repair/replacement. The wood has started to separate at the supports and at the corners of the window boxes.

2. The trim board at the southwest corner of the porch has water damage due to water penetration and will require repair/replacement of the wood. The trim board extends out creating a ledge allowing water to collect on the top edge of the board and cause the wood to rot.

Recommend estimate/repairs by a qualified contractor.
